**US Army Corps
of Engineers®**

Demonstration Erosion Control Project Monitoring Program

Fiscal Year 1995 Report

March 2000

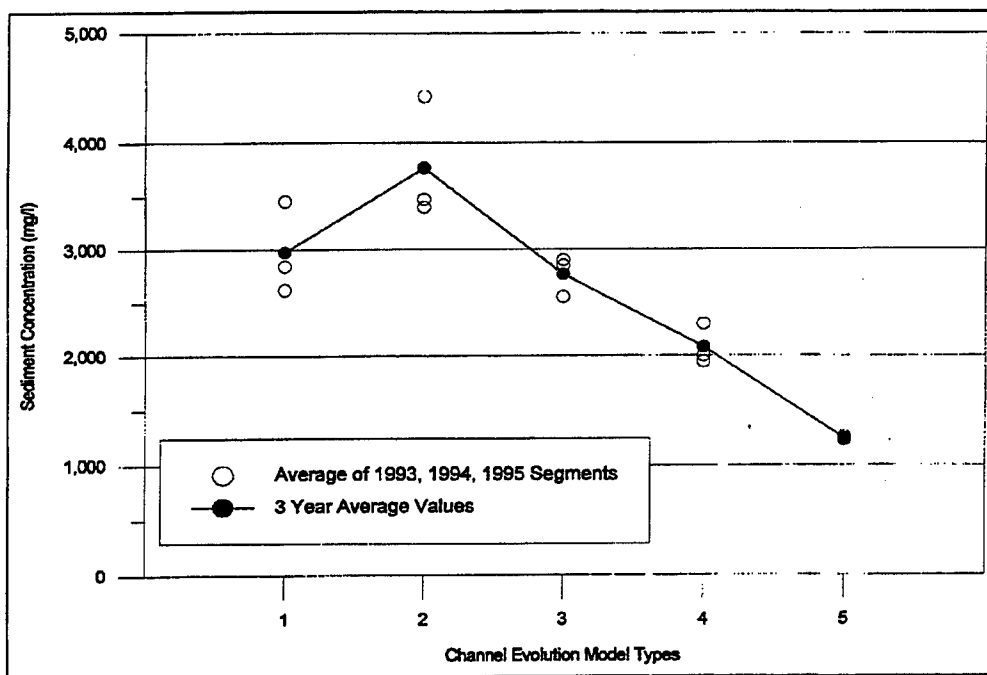
Figure 59. Computed sediment concentration for CEM types

The proposed structure location procedure would be to select an energy slope based on the desired sediment transport concentration. The sediment transport concentration of the CEM 5 reaches within the DEC monitoring reaches can be used to select a design slope. Figure 59 provides a summary of the sediment concentration for CEM types for 1993, 1994 and 1995; the line through the data is the average for each CEM type. Figure 4.4 can be used to estimate the energy slope. The data indicates the design slope for the CEM 5 concentration of 1000 mg/l would be approximately 0.001, and the CEM 4 concentration of 2000 mg/l would be 0.0014. Structures could be located using this range of bed slopes, which would reduce sediment concentration below the existing average sediment transport. A check could then be made comparing bed slope and energy slope, and adjustments could be made if required.
